BULLETIN TITLE: SEAT ATTACHMENT	
	CLASSIFICATION: SAFETY DIRECTIVE/SAFETY ALERT	
Letecká 255 686 04 Kunovice Czech Republic	Tel.:+420 773 984 338 info@brmaero.com www.brmaero.com	BULLETIN NUMBER: ALL-SA-0-0-0-ALL-0002-2021 Date of issue: 11.11.2021 Date of effect: 11.11.2021
		Revision no.: New issue Date of rev.: - Page: 1 Pages: 8

Annex 1 Seat attachment – photos

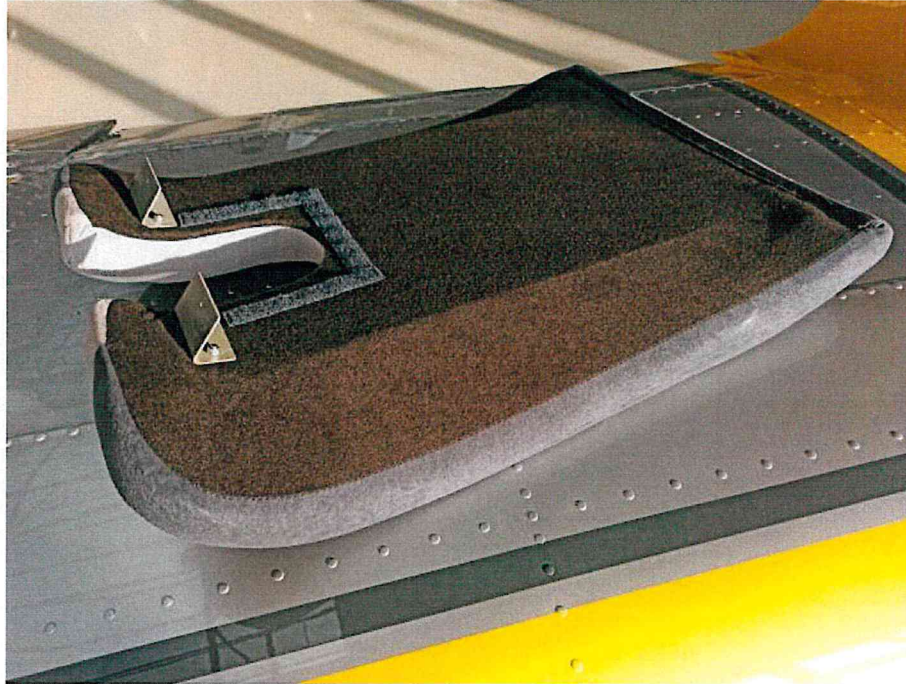
- 1.1.1 Type: BRISTELL
- 1.1.2 Model: All UL and LSA models
(UL=Ultra Light Aircraft, LSA=Light Sport Aircraft)
- 1.1.3 S/N: All BRISTELL airplanes with the original design of the bracket for seat attachment, see Figure 1.
Notes:
The original design was used until approx. May 2019.
Since May 2019, the new design is in use, see Figure 2.
- 1.1.4 Countries: All countries where Bristell aircraft operate.

If the seat can be lifted up easily, it is the original design with the straight brackets, see Figure 1.

Figure 1 Seat with original straight bracket

Check of both seats attachment.
Replacement of the seat brackets (4 pcs/per 1 aircraft) with new design.

Before the next take-off check the seat attachment (see Figure 3).
Before each take-off, the pilot should always check the possibility of full deflections of the control surfaces, including elevator in the fully aft direction.
At the next periodic inspection, but no later than 1 year from the date of issue of this bulletin, replace the original seat brackets with the new design.

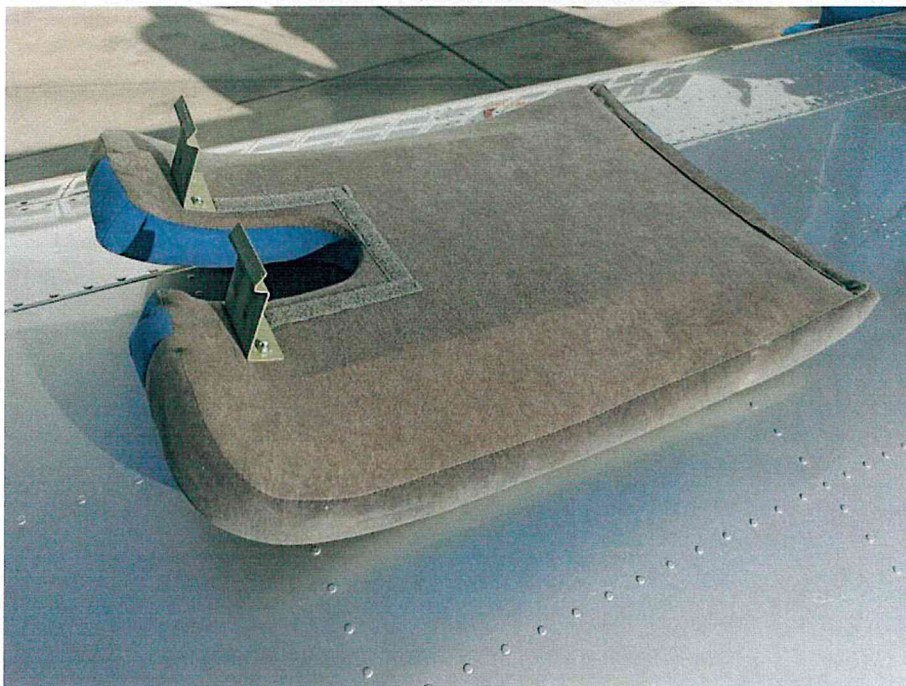
If the seat cannot be lifted up easily, it is a new design (Figure 2) which holds the seat sufficiently. In this case the brackets do not need to be changed and record the compliance with the bulletin in the Aircraft LogBook.

Figure 2 New bracket design for seat attachment

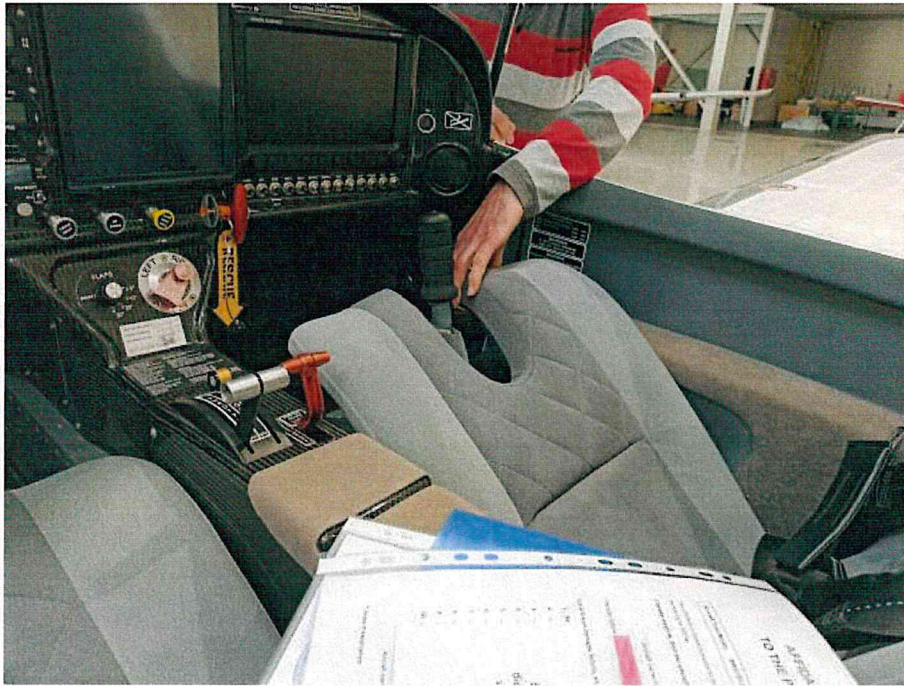
1. Check the attachment of the seat of your aeroplane, see Figure 3.

Figure 3 If the seat cushion can be lifted up quite easily, then it is the original design of the seat attachment with straight brackets.

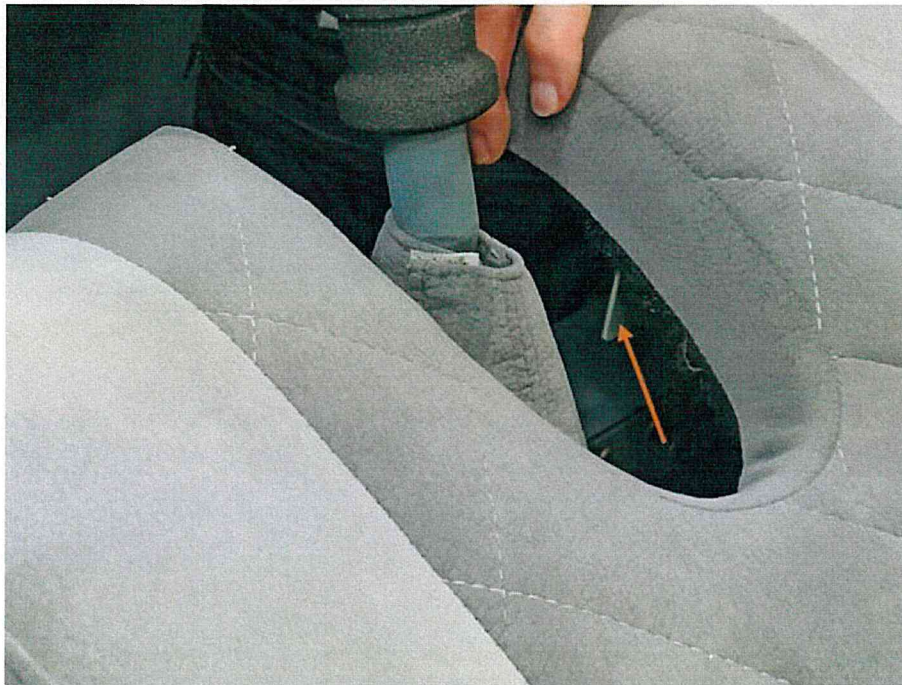
Figure 4 Detail view, arrow points to straight console

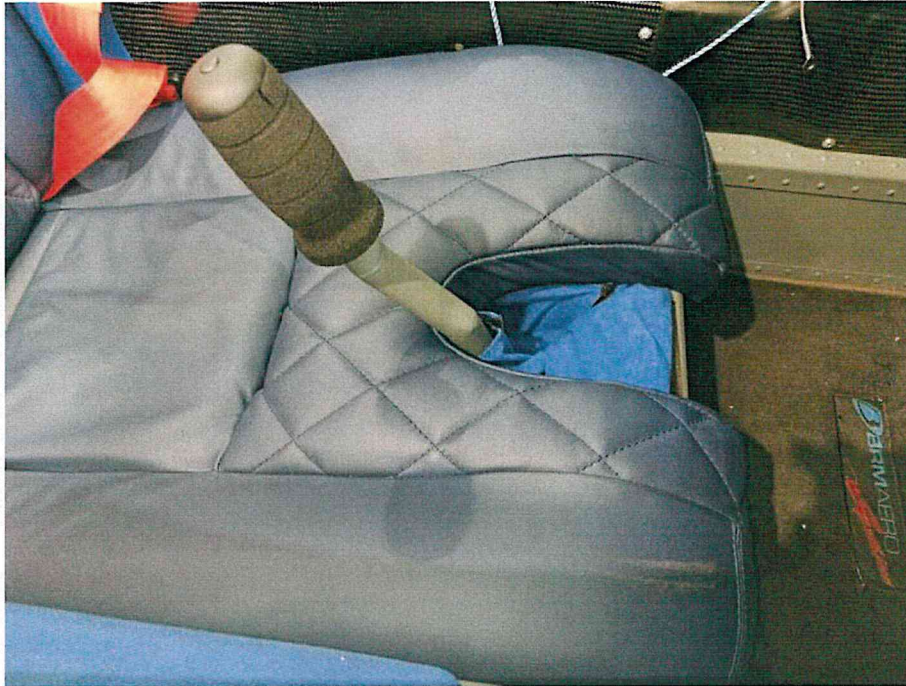
Figure 5 Control stick fully aft deflection if the seat is correctly fitted (brackets behind the main spar).

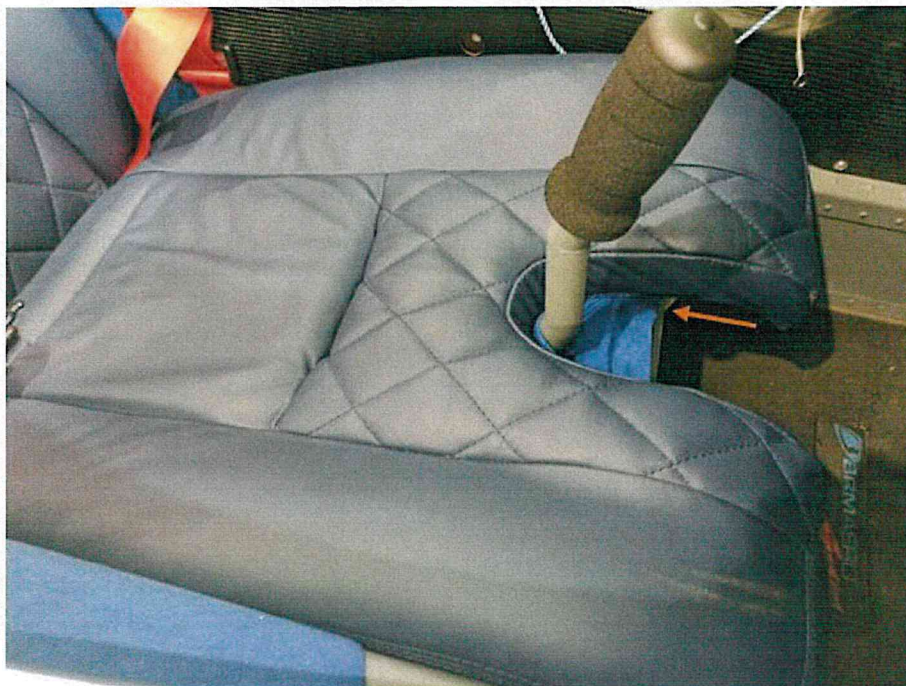
When operating Bristell aircraft with the original design of the seat attachment (see Figure 1), it has been found, that the seat can move up and forward, which may cause reduction of elevator fully aft deflection (see Figure 6).
This situation can occur for example, with an unoccupied seat when flying in turbulence or through a gust, when the seat is incorrectly fitted or when the pilot is settling into the seat.

Figure 6 Control stick fully aft limited deflection if the seat jumps up and forward (the console gets in front of the main spar, see arrow).
